VISION FULFILLED

A parish journey of worship space renewal

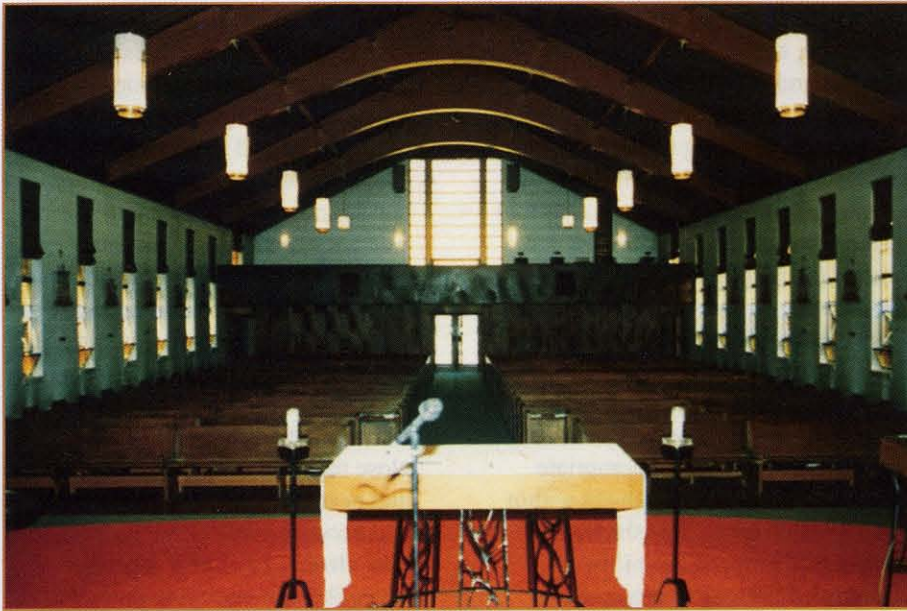
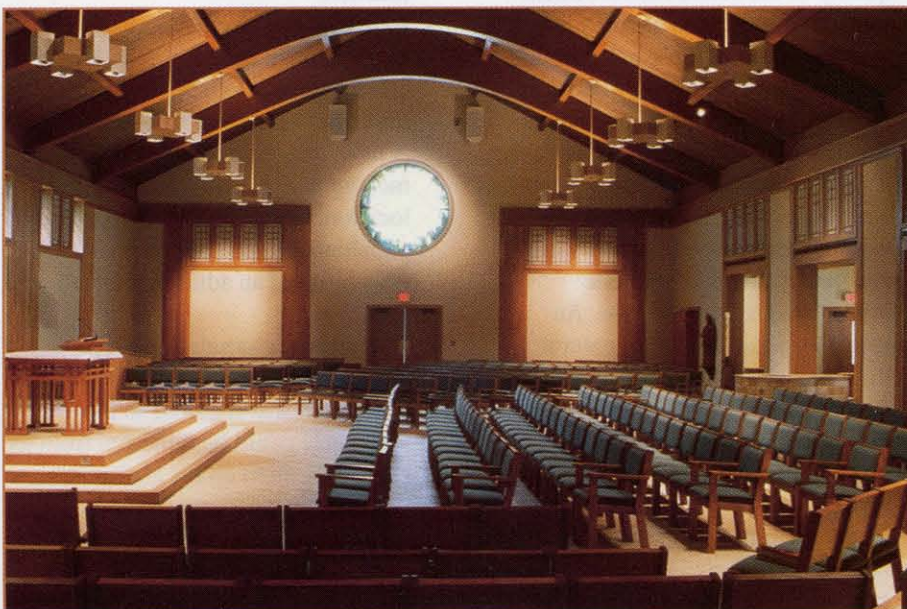
Dark shadows and cold angles (before, above) are replaced by gentle lighting, warm colors, and an open sense of welcoming (after, below).

visibility and acoustics. The interior was completely redone in the American Prairie style, with new cherry woodwork, porcelain tile floor, new lighting, and a new sound system. The room was carefully tuned to provide the desired acoustical environment by the subtle integration of acoustical materials into the wall finishes. Speakers for the sound system are hidden behind columns of the same acoustical fabric on either side of the altar. The new lighting accentuates the original building's beautiful wood beamed ceiling.

New windows were cut into the existing walls to provide natural light throughout the worship space. A southwestern window that was a constant source of glare was replaced with a new, smaller stained glass rose window. Architectural details from the original church were incorporated into the door surrounds at the main entry and the eucharistic reservation chapel. All liturgical furnishings were designed and crafted by the same craftsman in collaboration with the architect. New furnishings included the altar, ambo, tabernacle, processional cross, candlesticks, and credence table.
